FATAL FACTS

No. 8775-037

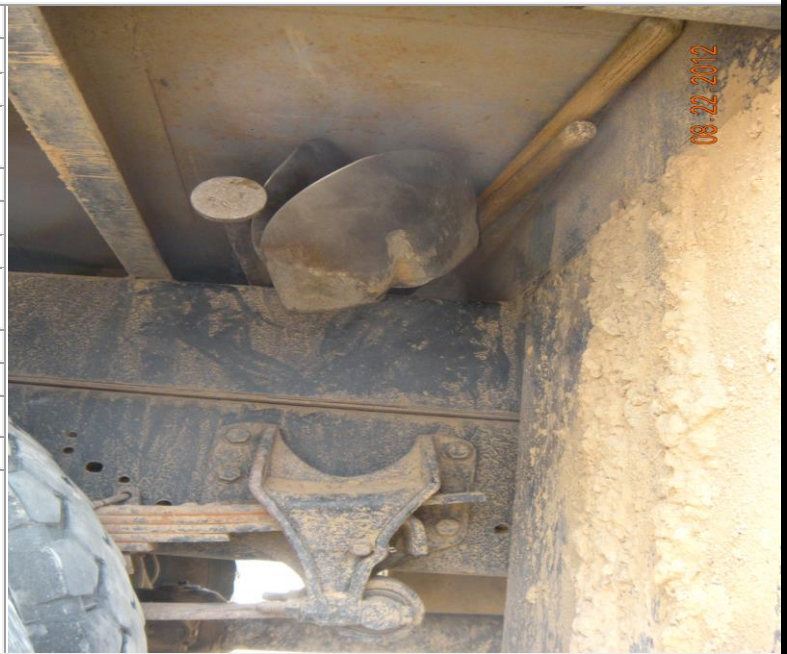
A delivery of a compressor had been made at an oil drilling site. A truck driver told his helper that he was going to move the truck away from the immediate work site to a position nearby. The helper acknowledged with a nod. As the driver began moving the truck, the helper moved into a position underneath the truck, apparently to secure tools or place a tool into the undercarriage. The deceased was crushed beneath the truck tires.

A recommendation was made to reconsider using the undercarriage of the truck as a storage space for tools.
