## **USE ATTAINABILITY ANALYSIS**

### **for Waters Located on Los Alamos National Laboratory as described in Sections 20.6.4.126 and 128 NMAC New Mexico Water Quality Standards, July 17, 2005**

Prepared by the New Mexico Environment Department  
Surface Water Quality Bureau  
August 2007

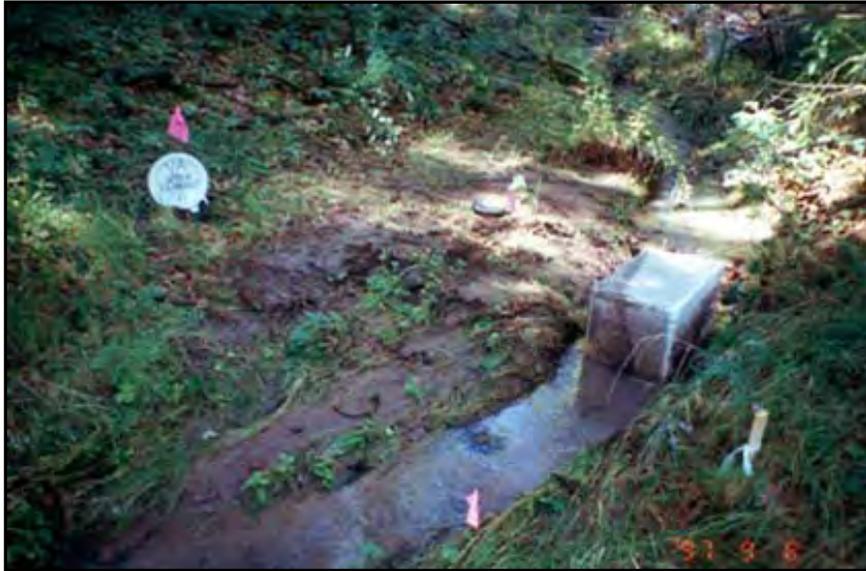
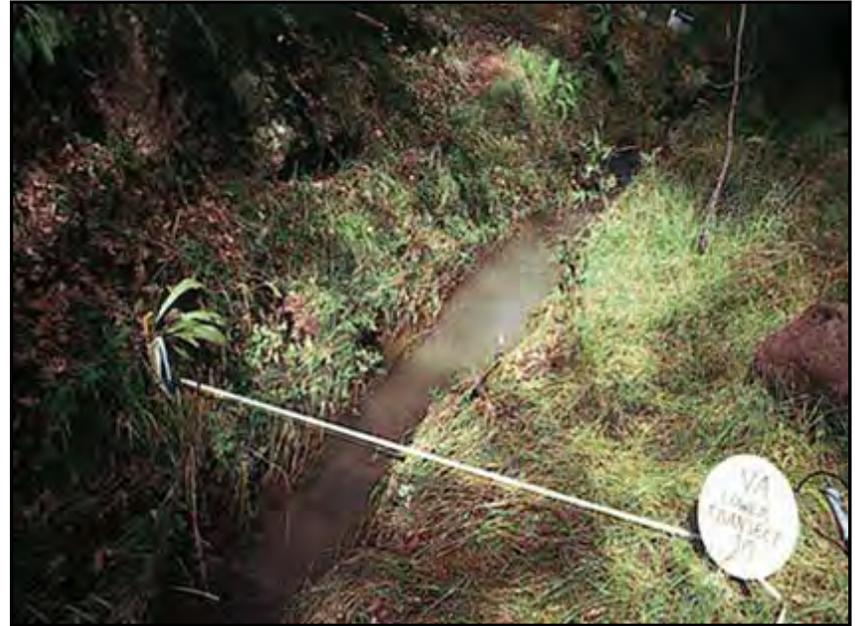
Cañon de Valle Creek

**Attachment 3**  
**Photos of Lusk and MacRae Sampling Stations in Segment 126**

Data collected by Lusk and MacRae (2002) and LANL stream gage data indicate that recreational use of Segments 126 and 128 is limited by low flows and water levels. Lusk and MacRae established six sampling stations on stream reaches included in Segment 126. Measurements (converted to English units) of stream discharge, wetted width and water depth at these stations are summarized in Table 1. These data indicate a maximum pool depth of approximately 9 inches and an average depth less than 5 inches. Photographs of typical pools and water levels at Lusk and MacRae sampling stations are shown in Attachment 3. Photographs, taken by representatives of the NMED Department of Energy Oversight Bureau, of stream reaches in Segment 128 are shown in Attachment 4.

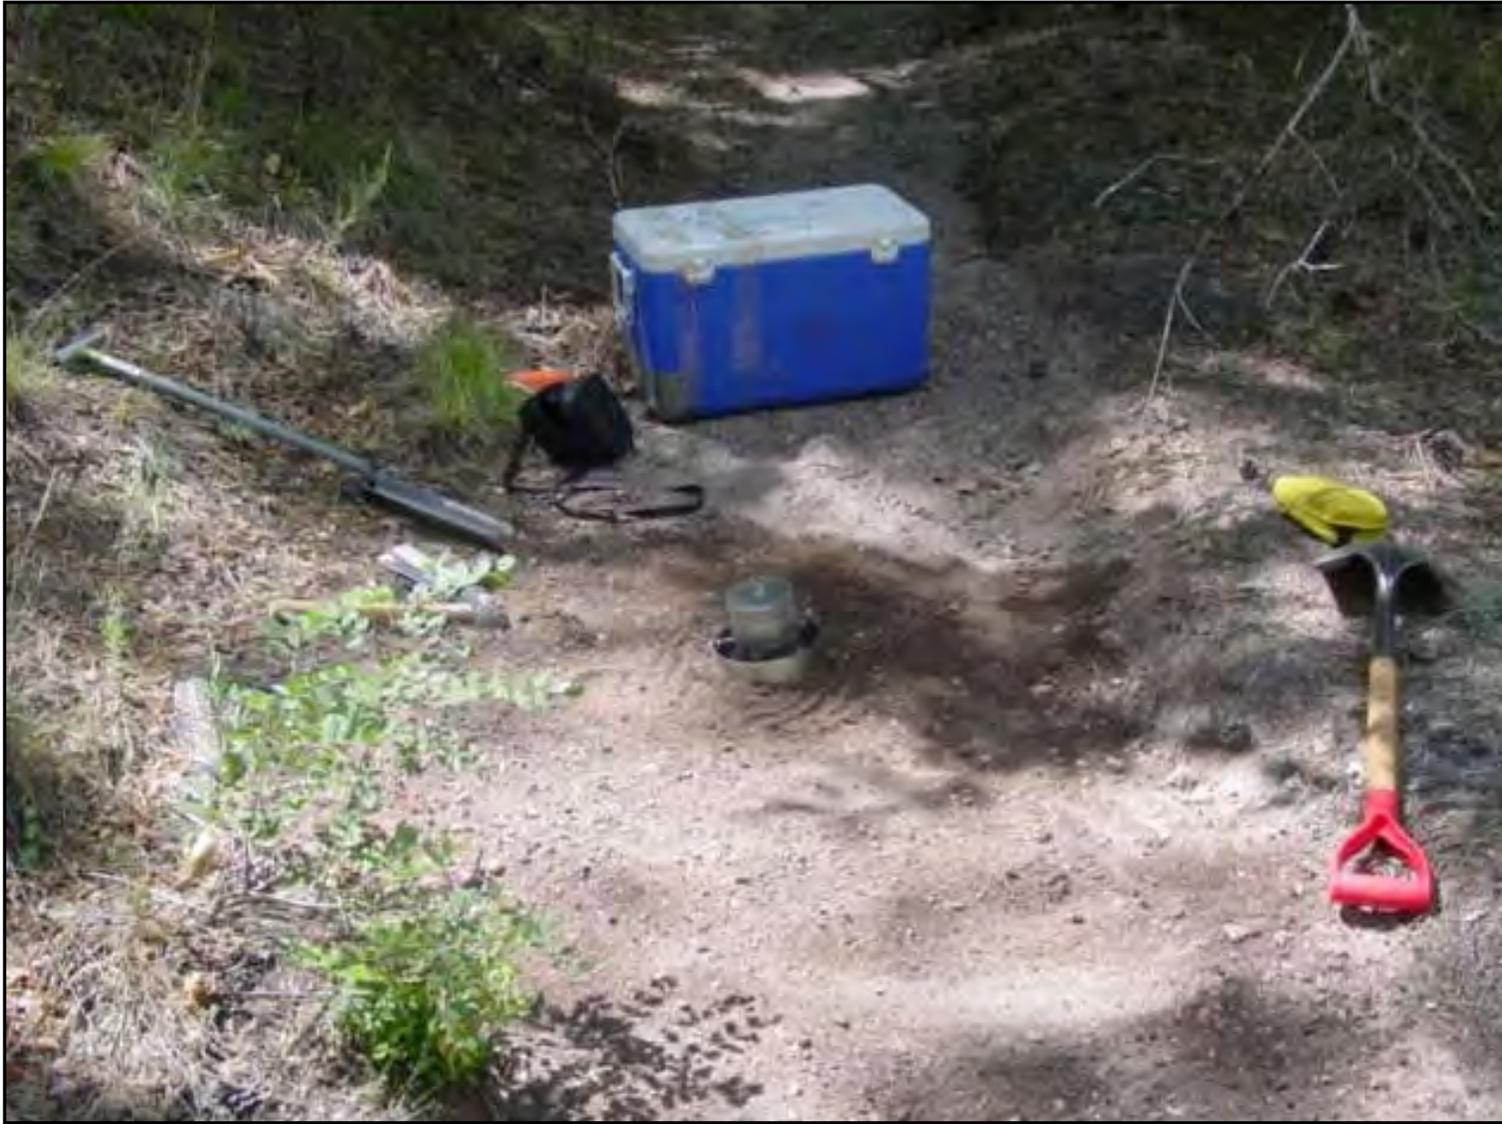
**Attachment 4**  
**Photos of Stream Reaches in Segment 128**  
Single-stage Sampler in Ancho Canyon, July 2006

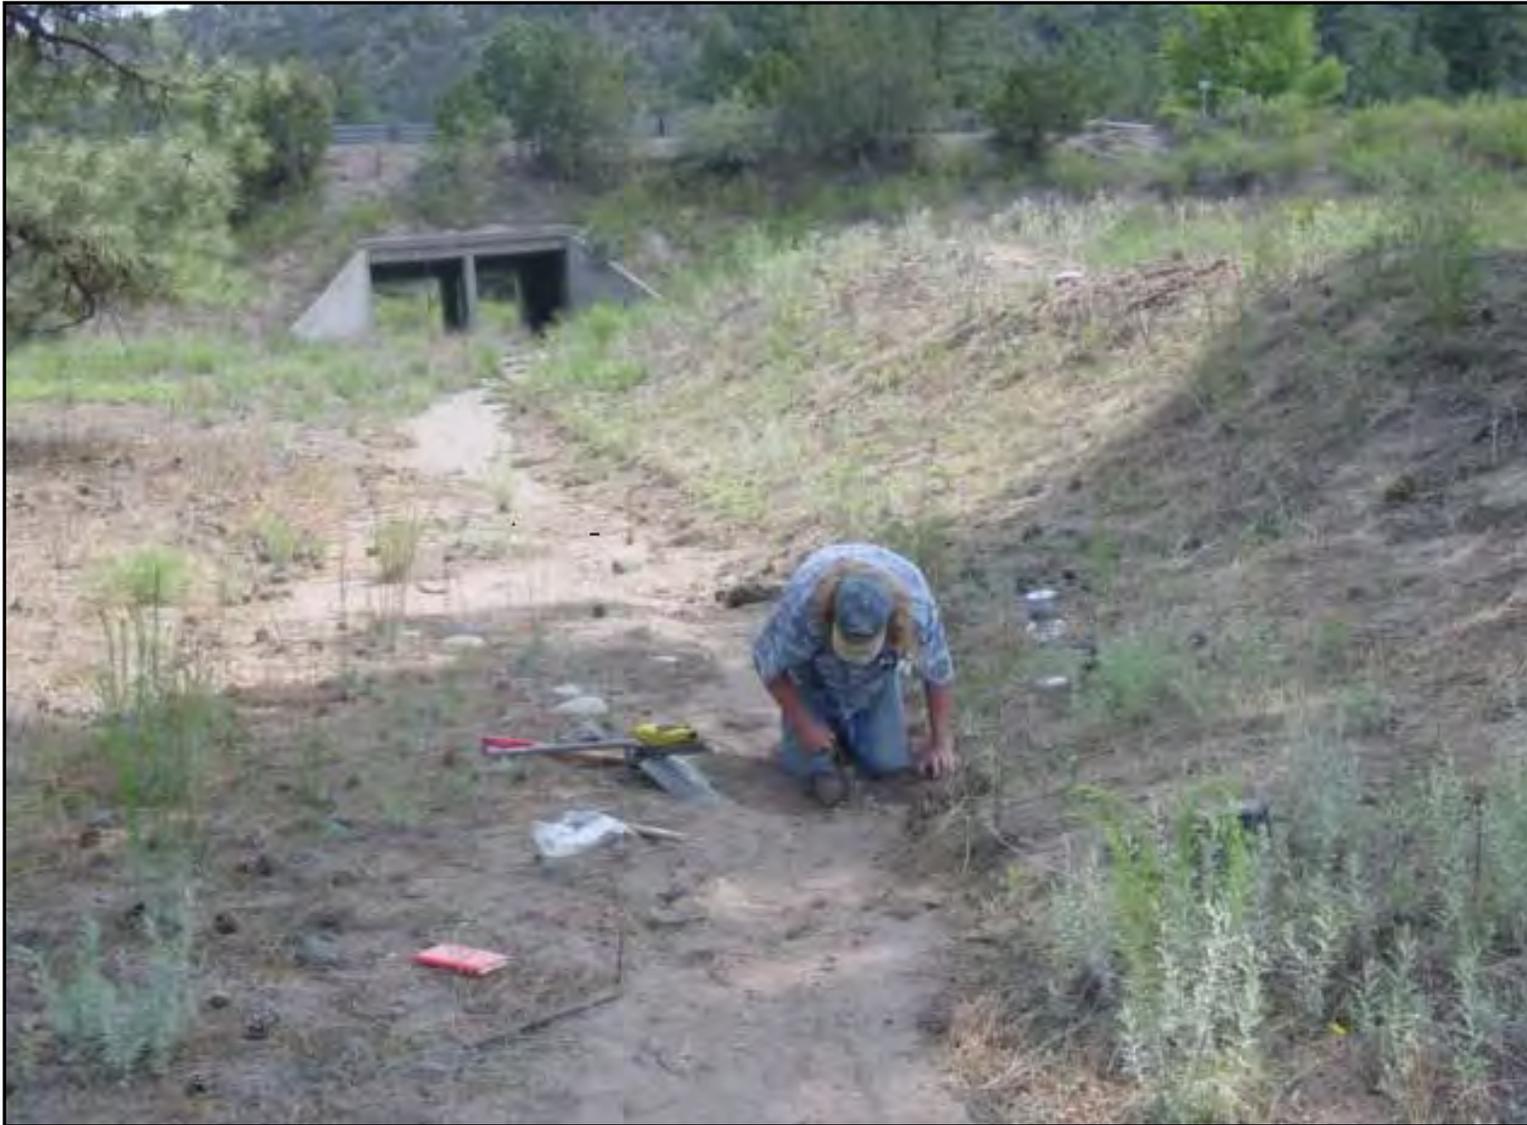
Installing Single-stage Sampler in Ancho Canyon July 2006

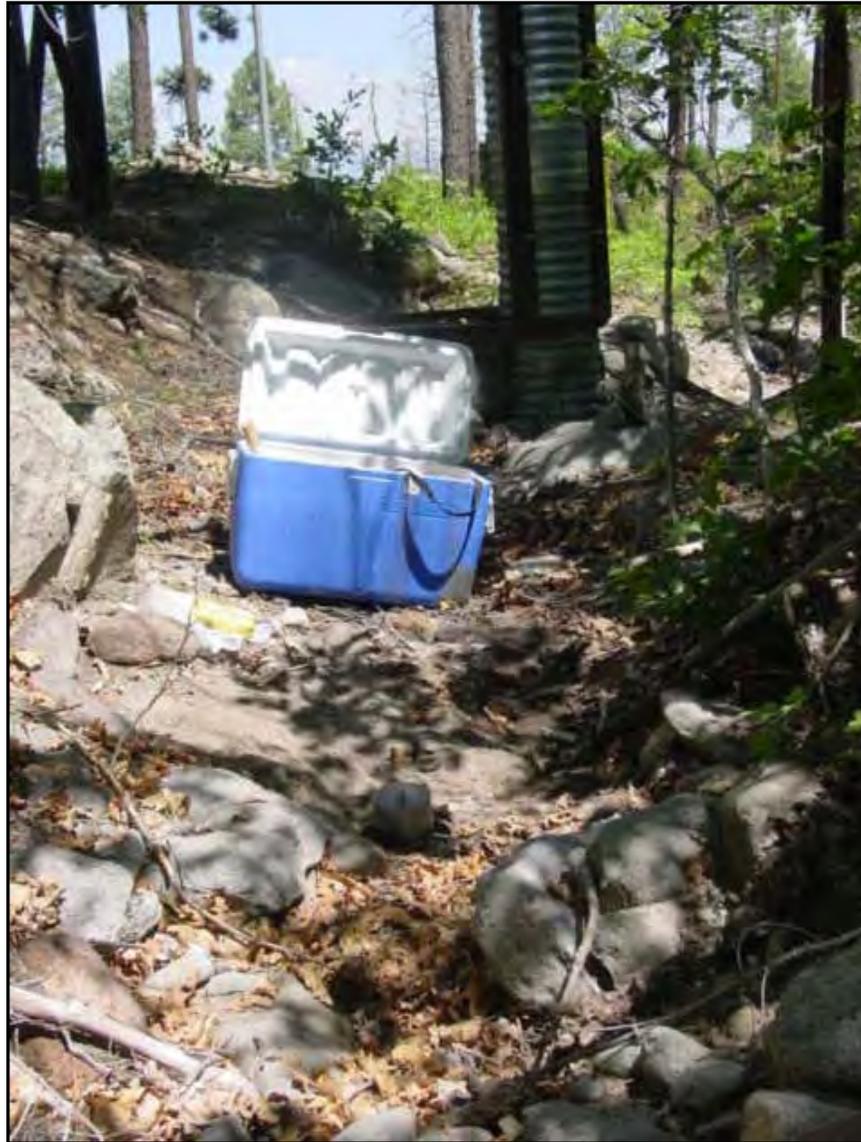
Single-Stage Sampler in Cañon de Valle, July 2006

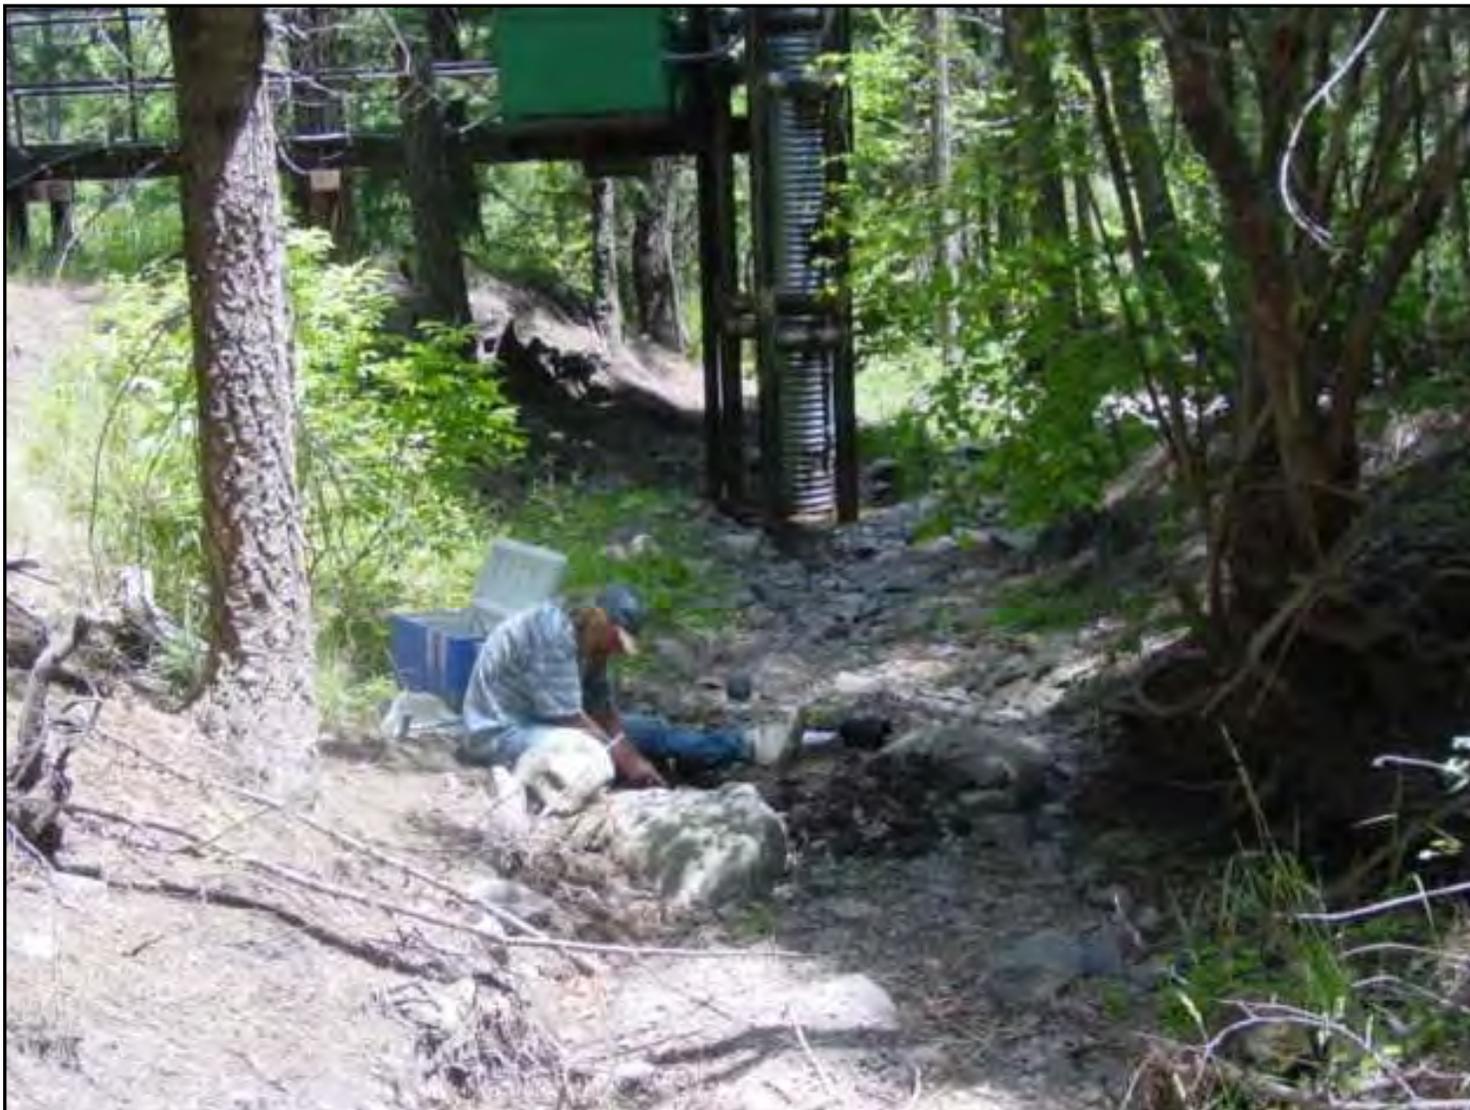
Installing Single-stage Sampler in Water Canyon, July 2006

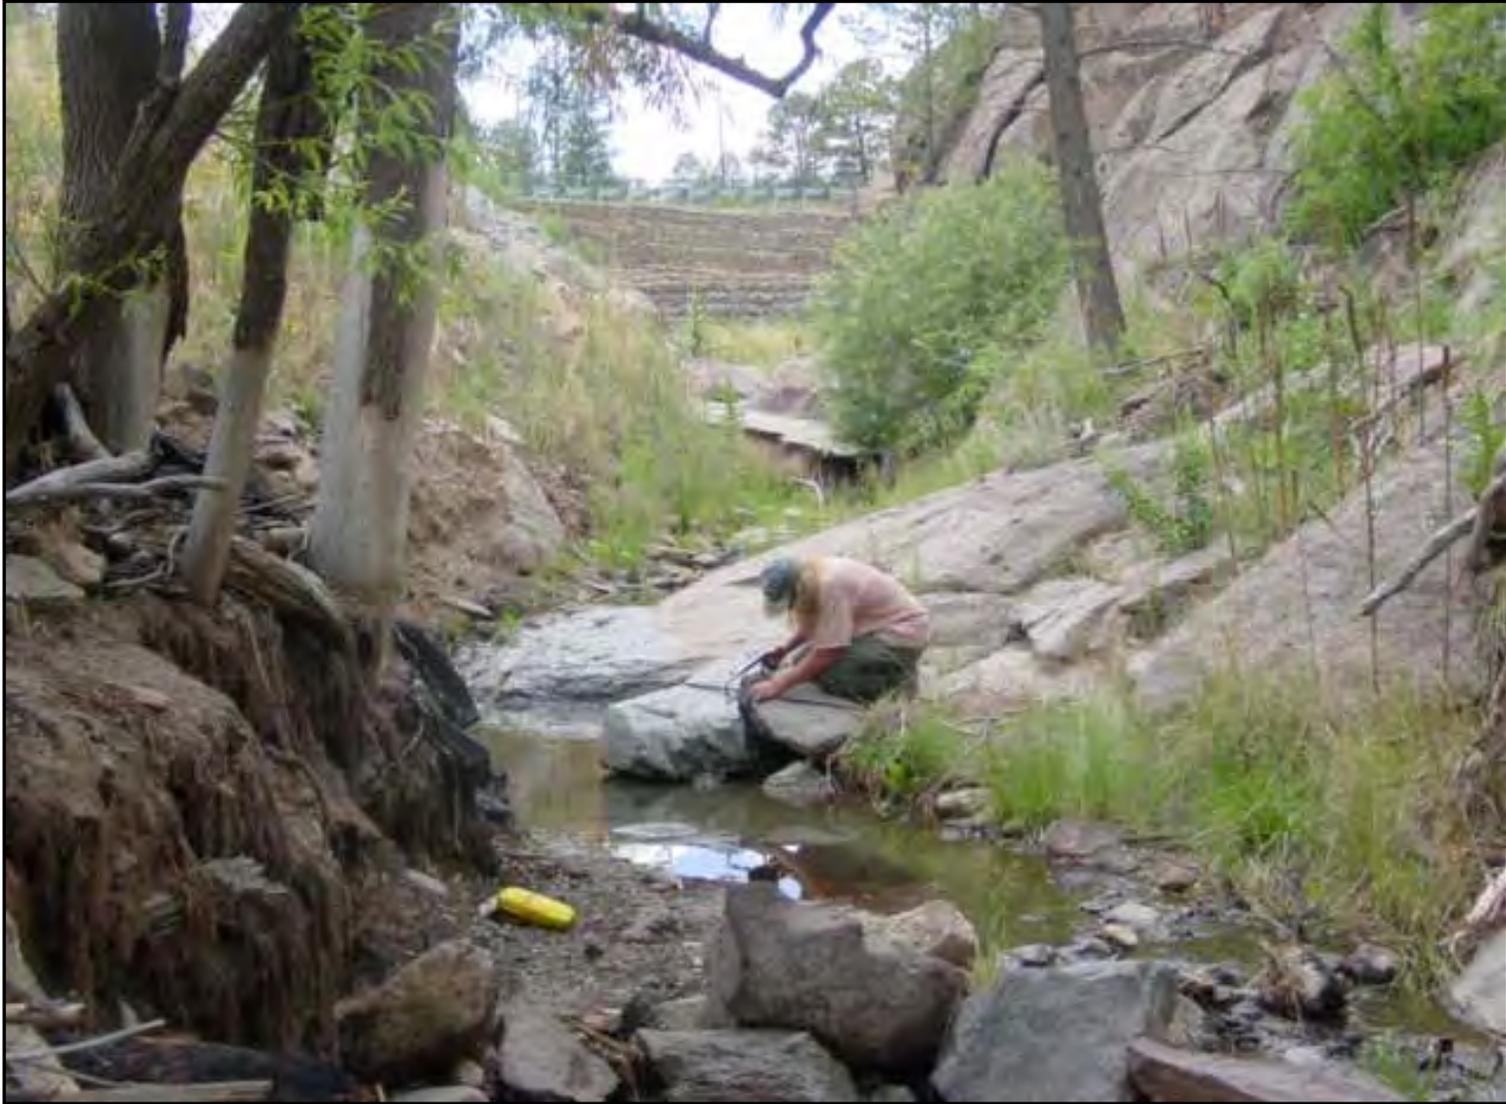
Installing Single-Stage Sampler in Pueblo Canyon, July 2006
