CLEARING THE WATERS

Newsletter

Volume 15, No.4

Vacas Asphalt Spill Cleaned Up

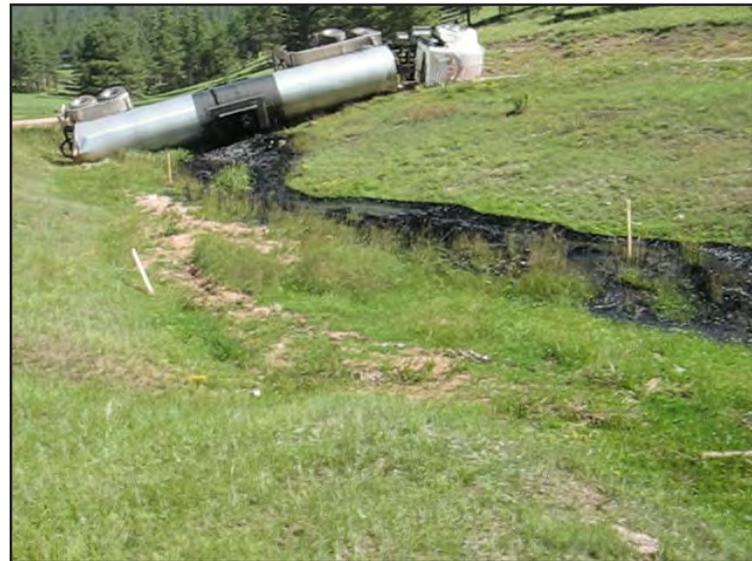
Asphalt Spill. Photo courtesy of Rudy Rios.

On August 10th, 2010 an accident occurred on NM Highway 126 about 12 miles east of Cuba, New Mexico. The highway was undergoing a chip seal procedure, and one of the ingredients used was a "hot oil asphalt slurry." Rudy Rios, President of NM Trout, was working in the area and observed an overturned tanker truck spilling an unknown quantity of asphalt slurry from a 5,000 gallon capacity tanker into a side drainage that flowed to a beaver pond on the Rio de las Vacas. The Rio de las Vacas is in the headwaters of the Jemez watershed, and is a popular recreational area and fishery. The driver had been attempting to turn around when the truck flipped over, and the material spilled out an unsecured top door/valve. The driver was not seriously injured, and the Department of Public Safety was contacted. Cactus Transport Inc., the owner of the tanker truck, took responsibility for the incident.

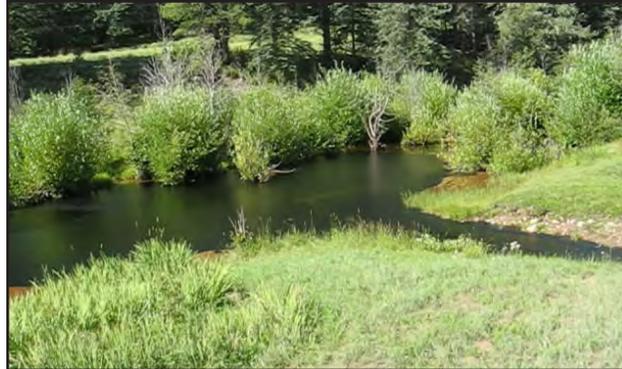
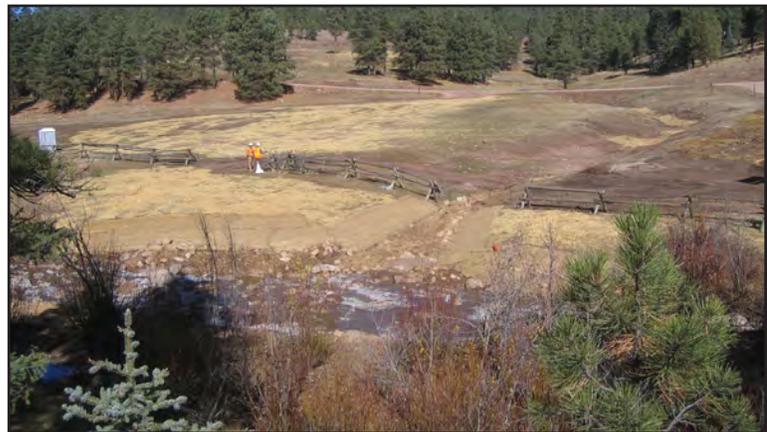
*Beaver Pond immediately after spill (above).
Photo courtesy of Rudy Rios.
Beaver Pond and drainage after remediation (below).*

Most transport companies carrying hazardous materials must have their tanks placarded and carry the Material Safety Data Sheet (MSDS). This information will assist emergency responders in the decision making process. Drivers should be aware of ways to contain materials in the event of an accident, and carry absorbent pads or blankets for petroleum products as part of a safety spill kit. In this event, the Santa Fe National Forest's Cuba Ranger District responded quickly by creating a berm that isolated the beaver pond, and diverted the flow of the Rio de las Vacas around the pond. Within several hours, they set up a series of straw bale check dams below the beaver pond to filter the flow without restricting the water.

The asphalt slurry cooled as it reached the stream and became less mobile. Most of the heavier hydrocarbons were contained in the beaver pond. There was no evidence that the beavers were active in this pond, and there was minimal fish mortality observed. It took approximately 12 weeks for the post-spill remediation to be completed. Cactus Transport Inc. worked diligently and stayed on site until the site was cleared by a multi-agency group that provided guidance. Although initial work is complete, the responsible party will continue to monitor the site.

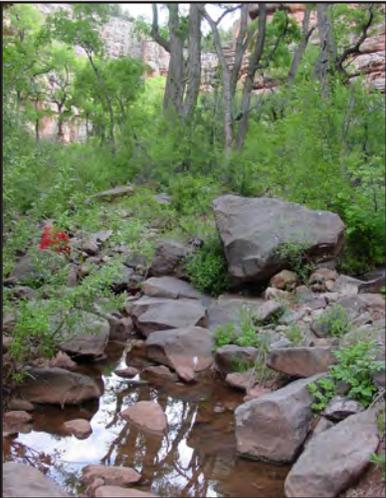
Perennial example - Rio Nutria
Zuni Watershed

SWQB has released a revised version of the Hydrology Protocol, a technical document developed to distinguish between ephemeral, intermittent and perennial streams and rivers in New Mexico. Such determinations are often key to applying the appropriate water quality standards to a waterbody. The protocol relies on hydrological, geomorphic, and biological indicators of the persistence of water. These characteristics are then ranked using a weighted, four-tiered scoring system for an objective, practical scoring mechanism. The protocol can be used to provide technical support for a use attainability analysis (UAA), or to identify unclassified waters within an otherwise classified segment. However, the protocol is designed solely to aid in water quality standards determination and the resulting determinations have no bearing on water rights or other non-SWQB programs.

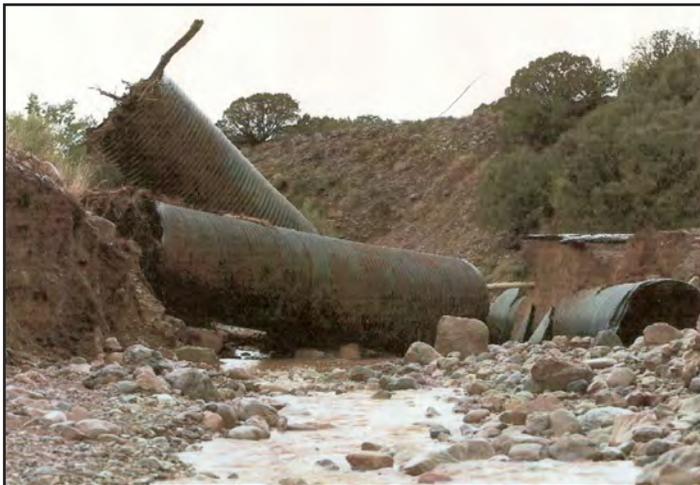
Flood damage on Las Huertas Creek, July 2006

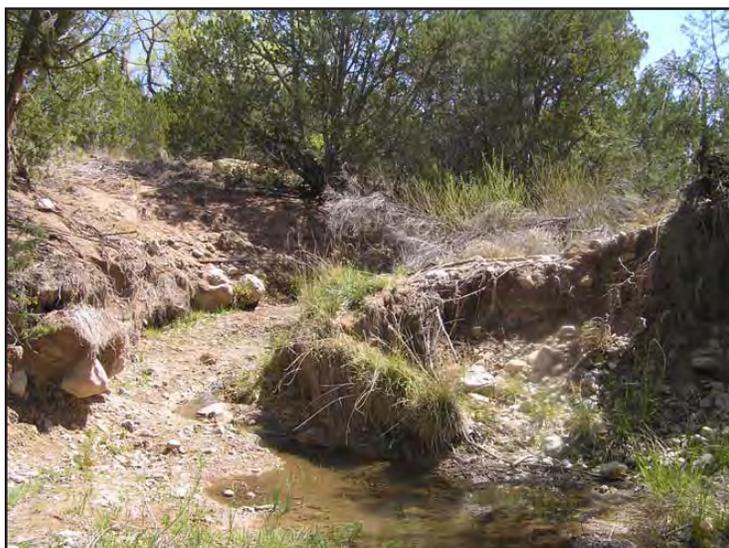
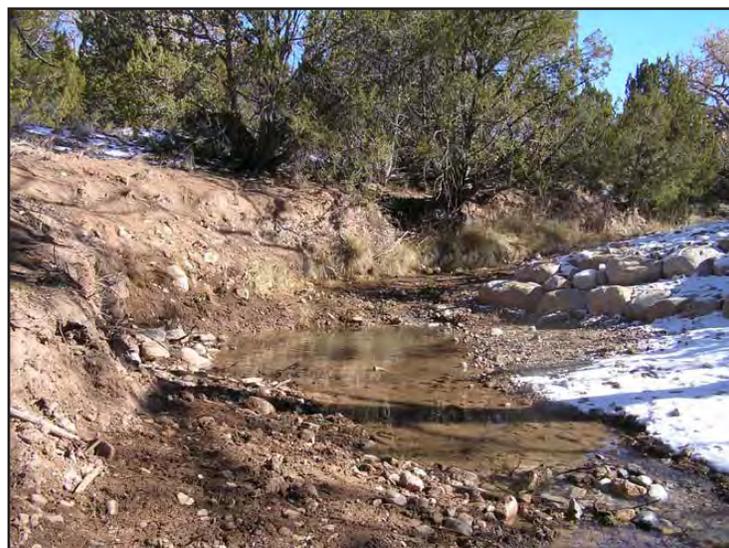
Restoration of deep downcut gully and back-eddy area at Van Driessche/Bladergroen property boundary – (view upstream). Note baffle installation on right and restoration of floodplain. Photos courtesy of R. Bandeen

For the Las Huertas Watershed Project, a sediment load reduction was estimated based on implementation of three types of best management practices (BMPs). Each type of BMP was either in-stream or in the riparian area; permitting an assumption that erosion rates are roughly equivalent to sediment loading to the stream. Fencing of riparian areas (mainly to exclude wild horses) was applied on eight percent of the "pastureland" land use category. The BMP was assumed to be effective at reducing sediment and nutrient loading by 60% from the area where it was applied. A separate wetland restoration was applied to 0.005% of a user defined rangeland land use category. That BMP was assumed to reduce sediment loading by 50%, nitrogen loading by 20%, and phosphorus loading by 40%. Approximately 4,000 feet of streambank, with an average height of approximately ten feet, were stabilized with vanes, weirs, baffles, and cross vanes installed following a natural channel design based in fluvial geomorphology. An average lateral erosion rate of 0.03 ft per year was estimated for these 4,000 feet of streambank, and the structures were assumed to reduce the lateral erosion rate by 45%.
